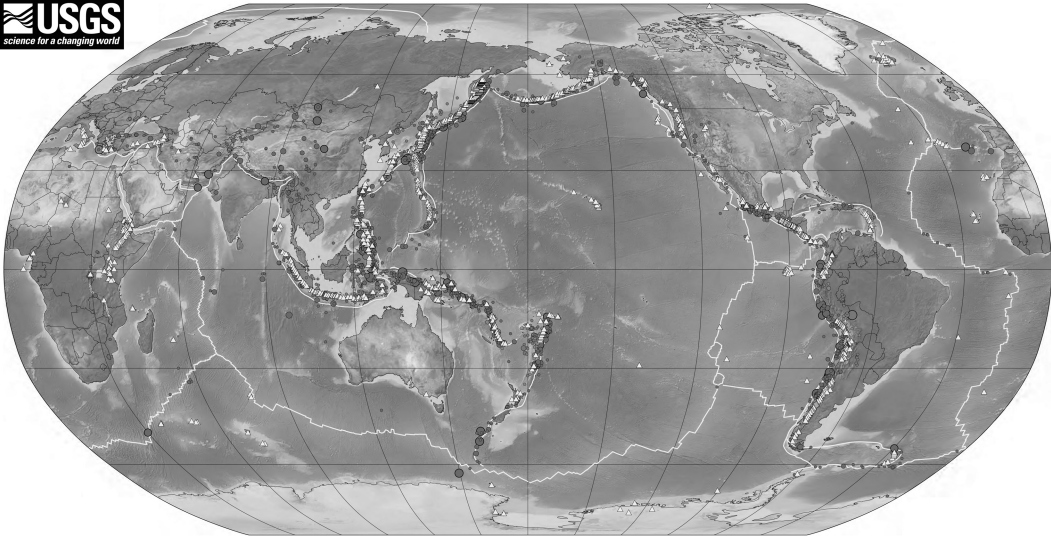
Figure 2.1 World seismicity between 1900 and 2012. (From United State Geological Survey – USGS.)

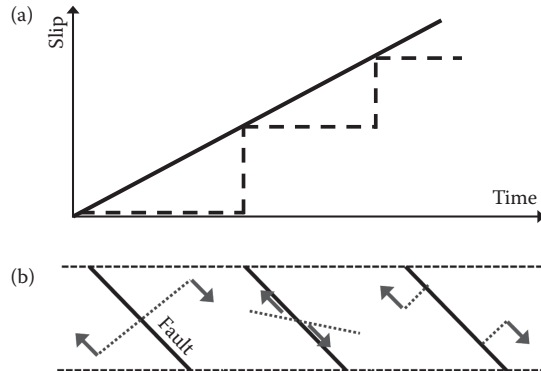
Figure 2.3 Elastic rebound theory: (a) slip as a function of time; (b) from left to right: initial stage, straining before earthquake, after earthquake.

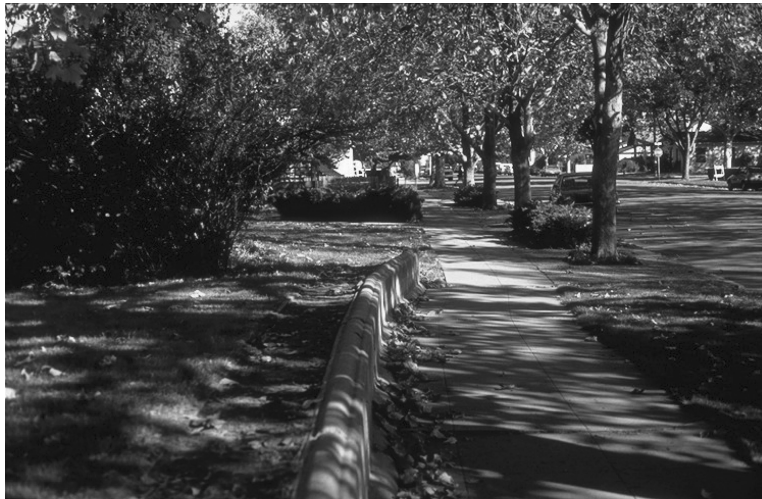
Figure 2.4 Fence offset in Hollister, California.

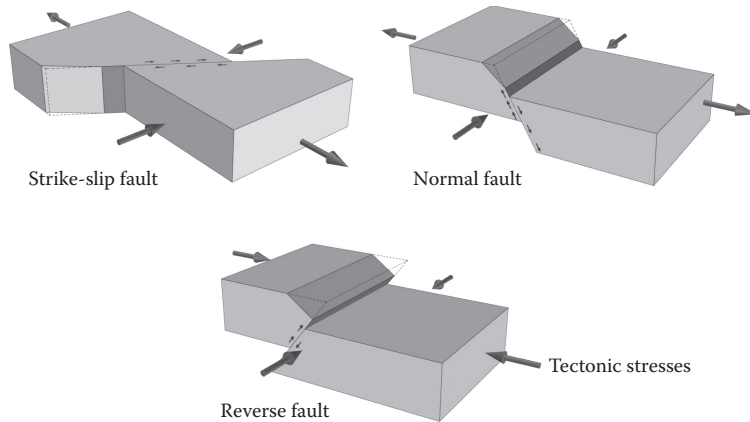
Figure 2.5 Fault types.

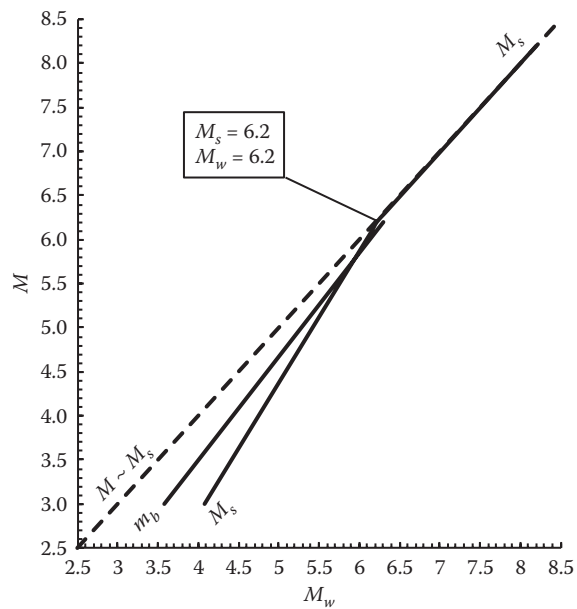
Figure 2.6 Relationship between magnitude scales.

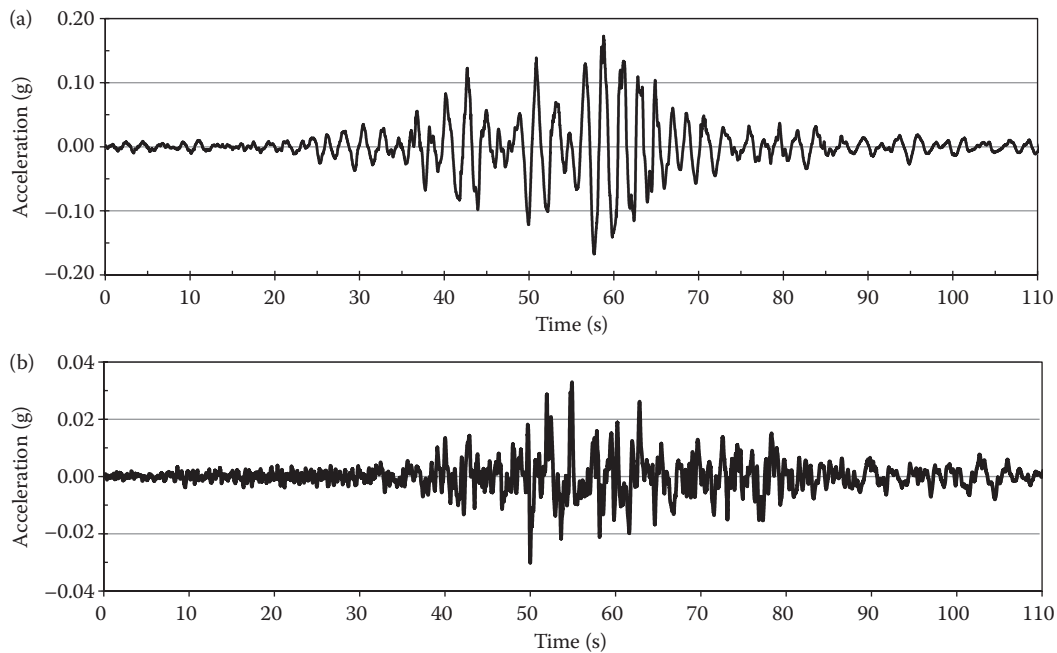
Figure 2.7 Records of the 1985 Michoacán Guerrero earthquake in Mexico City: (a) SCT (soft soil); (b) Tacubaya (rock).

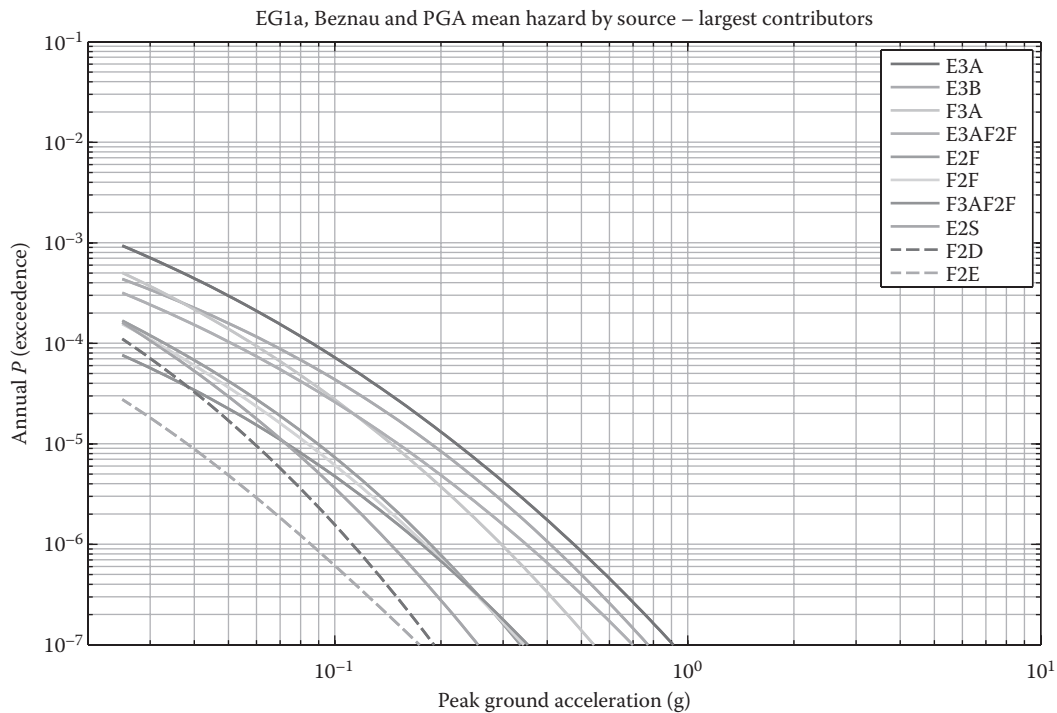
Figure 2.8 Hazard curves: each curve corresponds to a given seismic source.

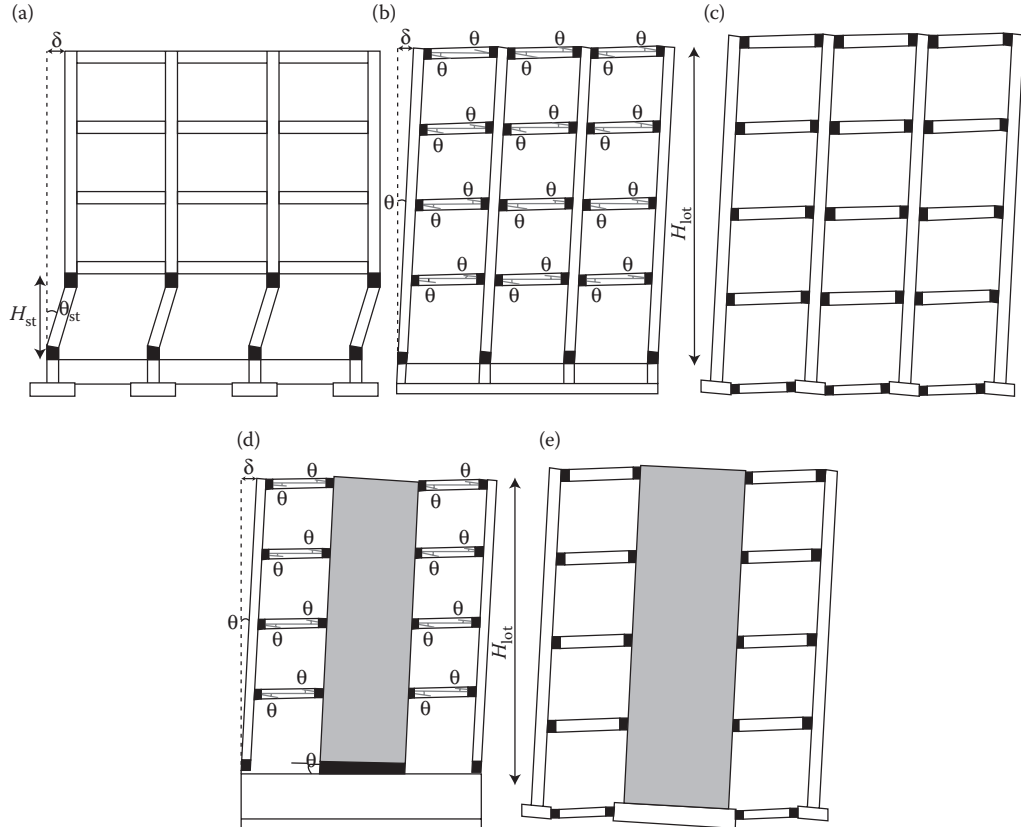
Figure 2.9 Side-sway plastic mechanisms in concrete buildings: (a) soft-storey mechanism in weak column-strong beam frame; (b), (c) beam-sway mechanisms in strong column/weak beam frames; (d), (e) beam-sway mechanisms in wall-frame systems.

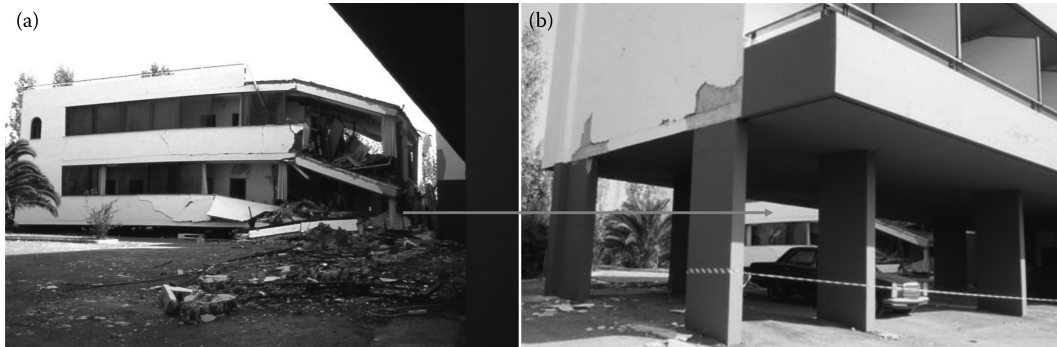
Figure 2.10 (a) Collapse of open ground storey building; (b) collapsed building shown at the background; similar building at the foreground is still standing with large ground storey drift.

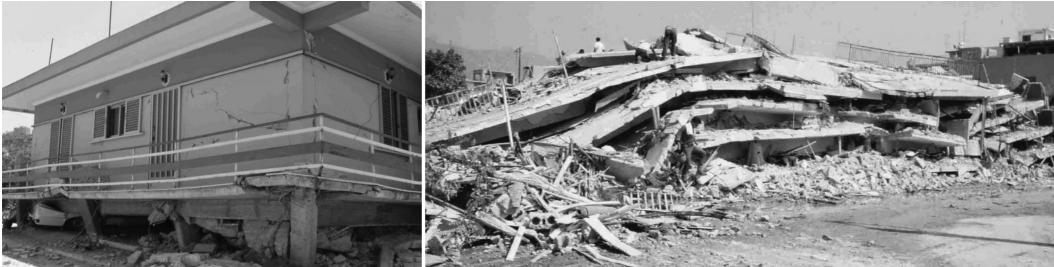
Figure 2.11 Typical collapses of frame buildings with open ground storey; 'pancake' type of collapse shown on the right.

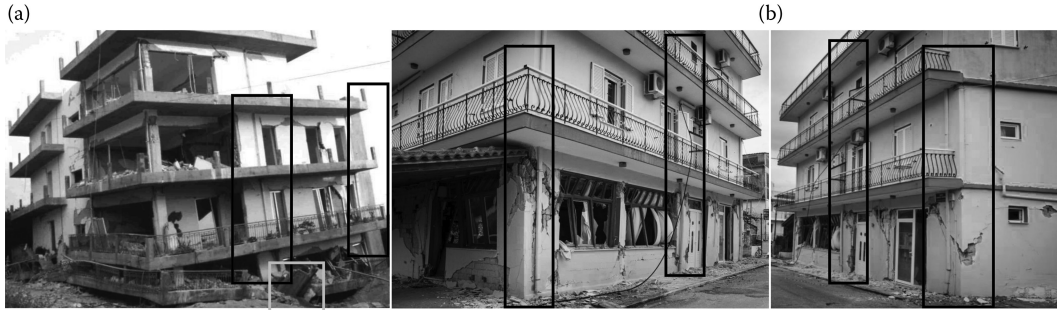
Figure 2.12 Role of walls in preventing pancake collapse of otherwise condemned buildings.

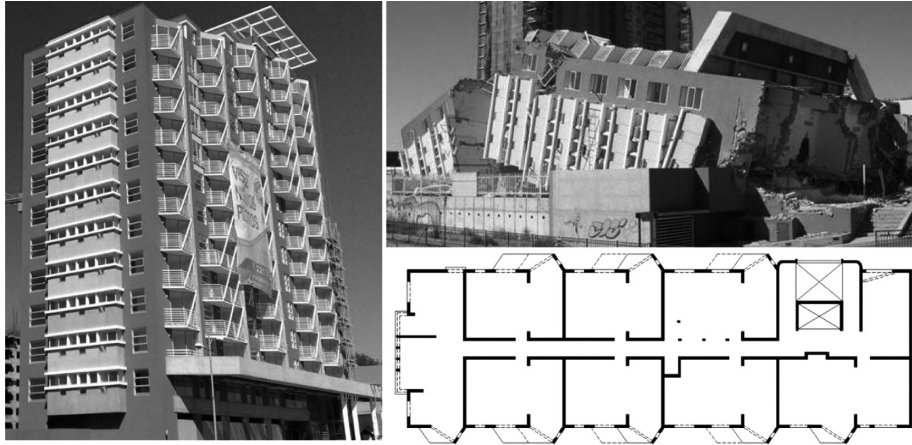
Figure 2.13 Collapse of Alto Rio wall building in Concepción, Chile; February 2010 earthquake (structural walls are shown in black in the framing plan).

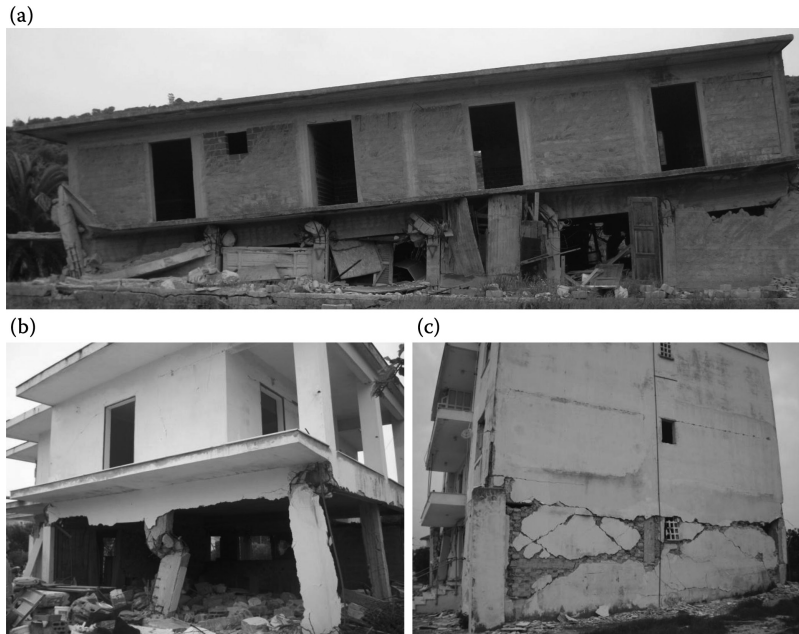
Figure 2.14 Typical concentration of failures or damage in ground storey (a), (b) with role and damage to infills shown in (c).

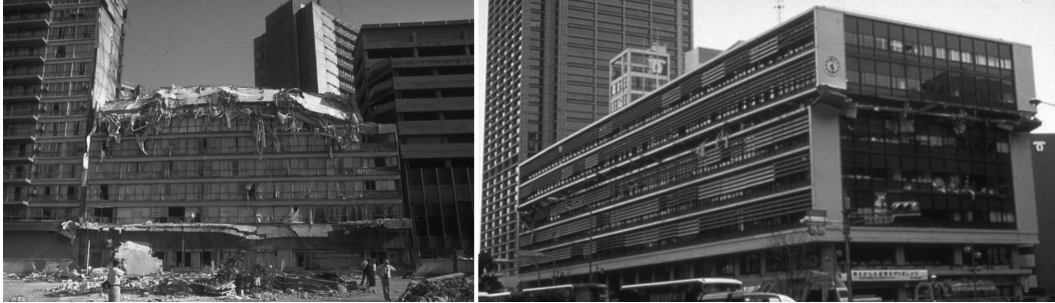
Figure 2.15 Collapse of top floors in Mexico City (1985) or of an intermediate one in Kobe (1995).

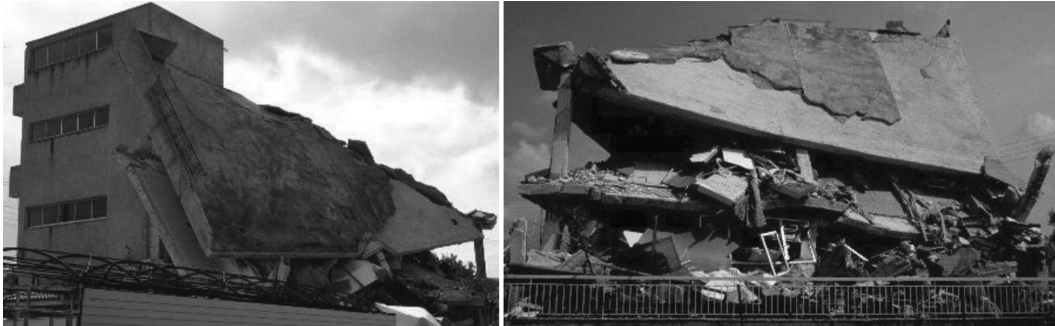
Figure 2.16 Collapse of flexible sides in torsionally imbalanced building with stiffness concentrated near one corner.

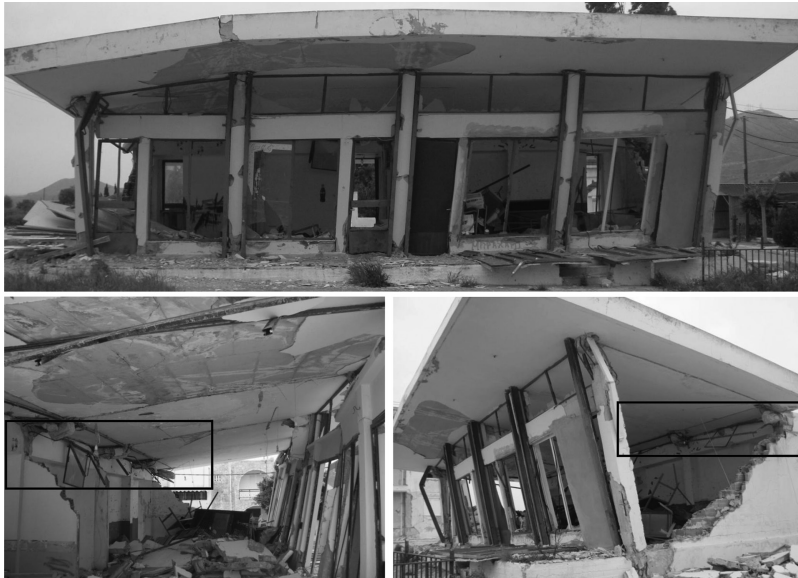
Figure 2.17 Shear failure of short columns on stiff side (inside rectangle) causes collapse of flexible side as well.

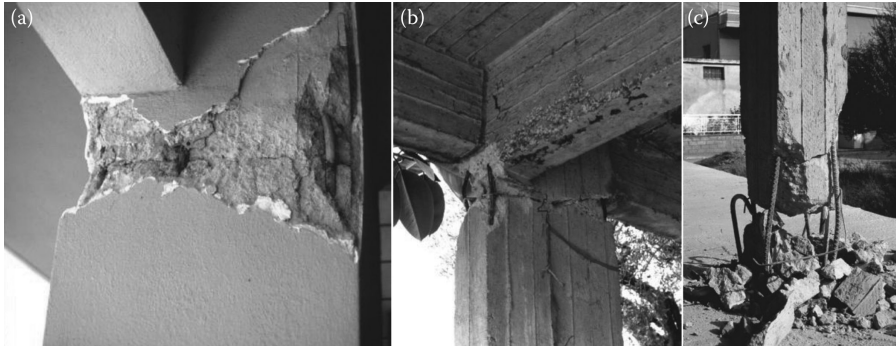
Figure 2.18 Flexural damage (a) or failure (b, c) at column ends.

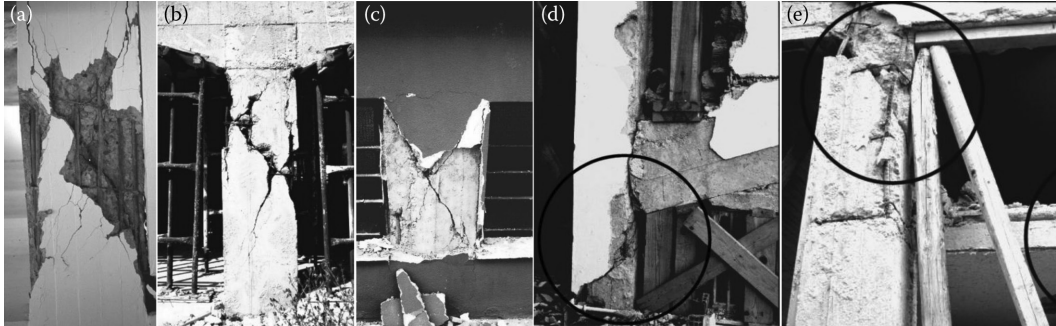
Figure 2.19 Shear failure of columns, (a)–(e), including a captive one between the basement perimeter wall and the beam (c) and short columns due to mid-storey constraint by a stair (d) or a landing (e) supported on the column.

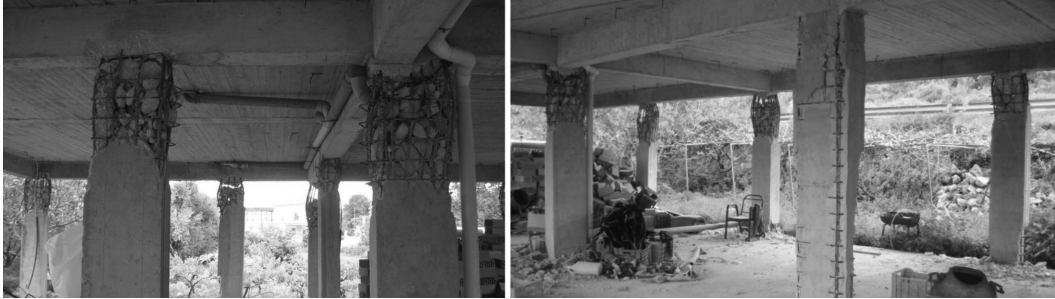
Figure 2.20 Despite complete failure of columns across the ground storey, their residual axial load capacity still supports gravity loads.

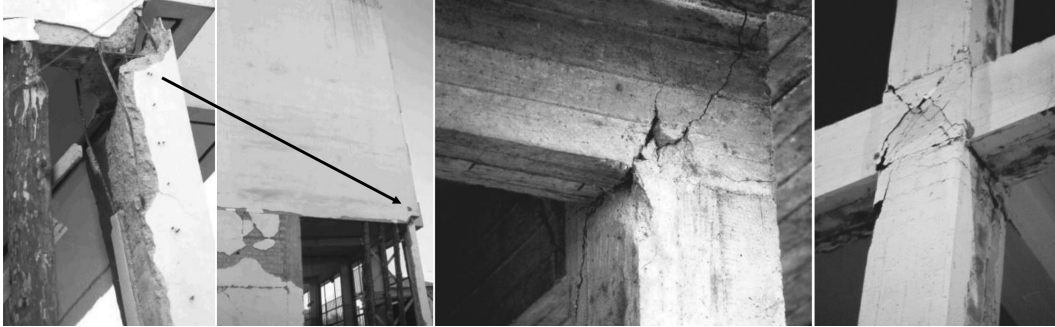
Figure 2.21 Shear failure of beam–column joints.

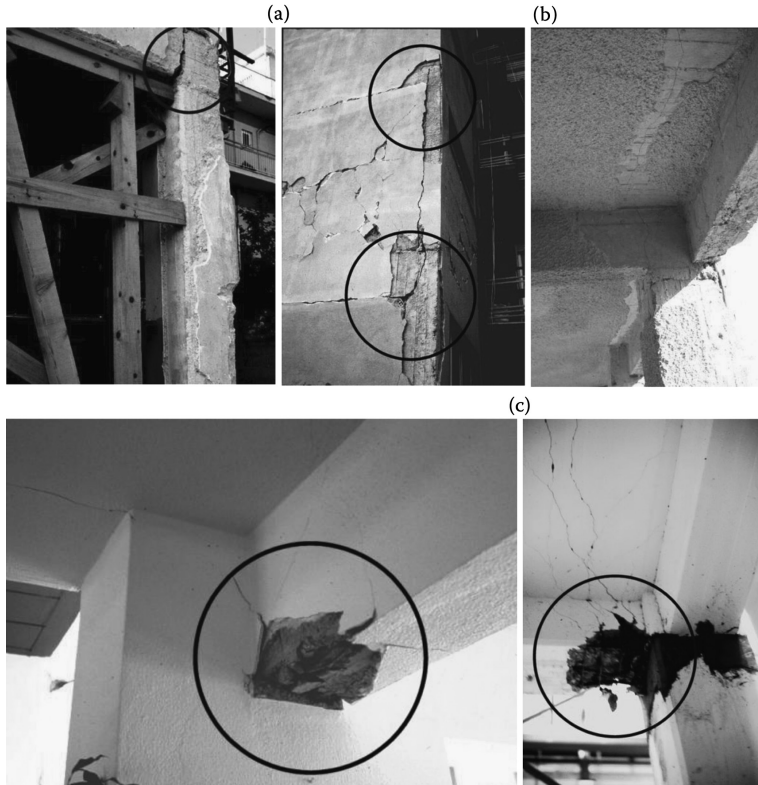
Figure 2.22 Typical features of beam behaviour: (a) pullout of beam bars from narrow corner column, due to short straight anchorage there; (b) wide crack in slab at right angles to the beam at the connection with the columns shows the large participation of the slab as effective flange width in tension; (c) failure, with concrete crushing and bar buckling at bottom flange next to the column.

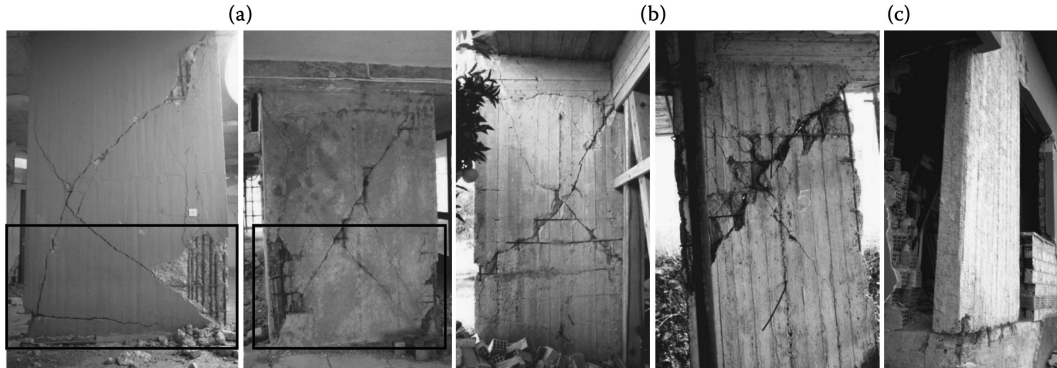
Figure 2.23 Typical failures of concrete walls: (a) flexural, with damage in shear; (b) in shear; (c) by sliding shear.

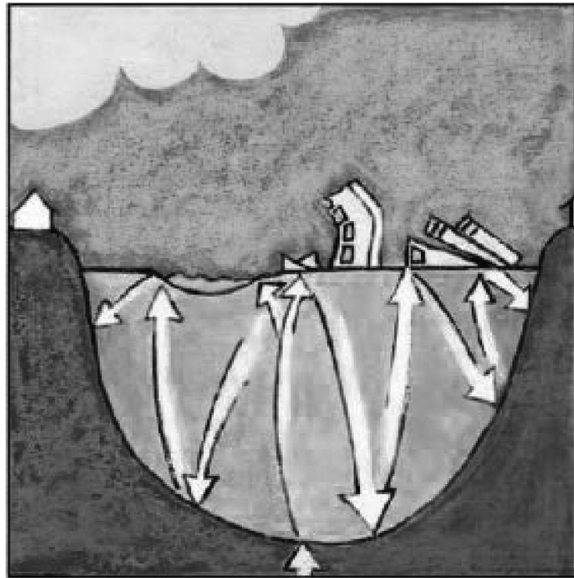
Figure 2.24 Illustration of wave trapping in sedimentary basins.

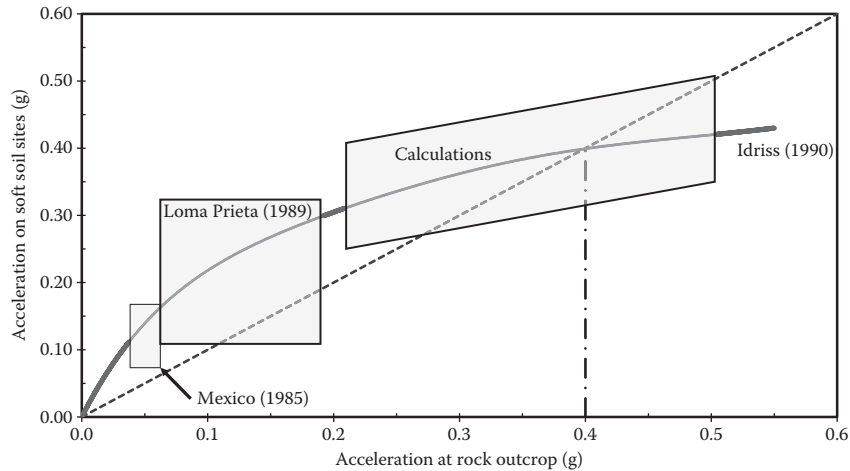
Figure 2.25 Relationship between PGA on rock and PGA at ground surface.

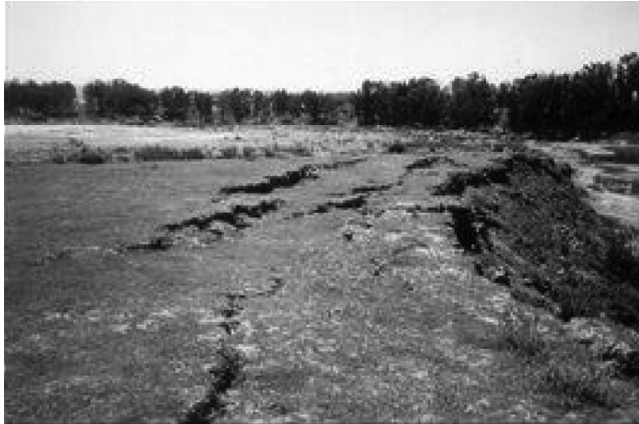
Figure 2.26 Lateral spreading (El Asnam, 1980).

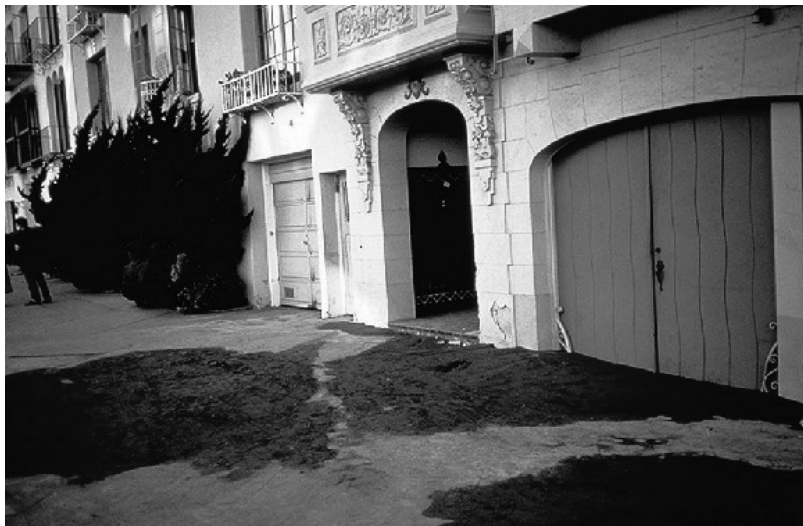
Figure 2.27 Liquefaction-induced settlement in Marina district (Loma Prieta earthquake, 1989).

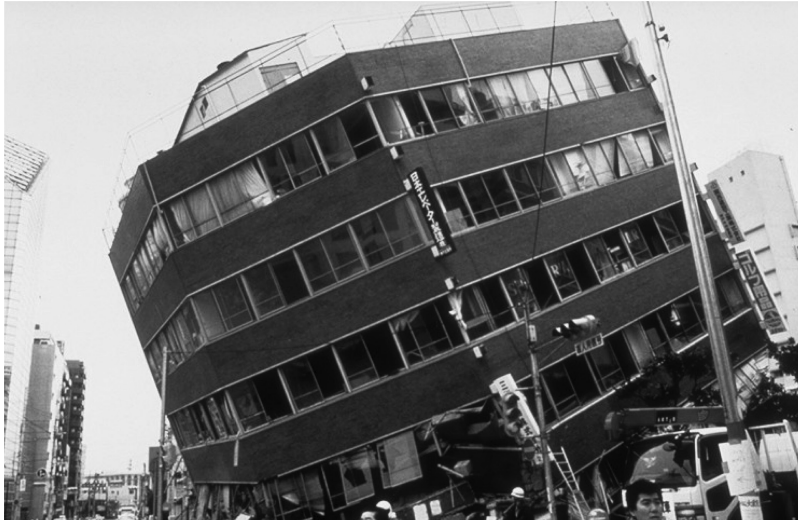
Figure 2.28 Bearing capacity failure due to liquefaction (Hyogo-ken Nambu earthquake, 1995).

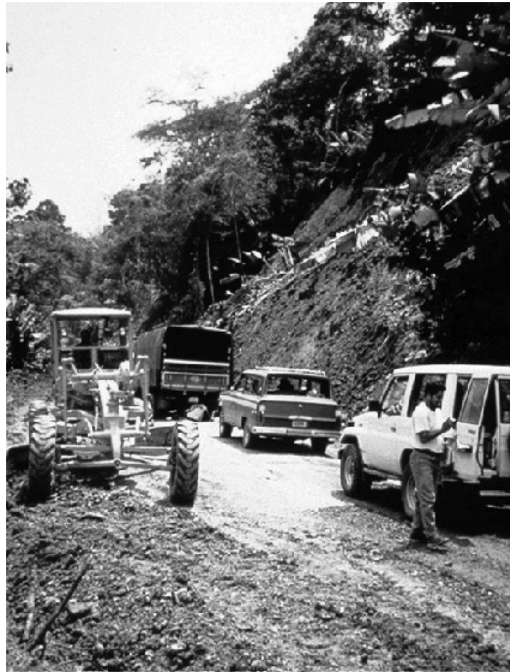
Figure 2.29 Slope failure on State Highway 17, California (Loma Prieta earthquake, 1989).

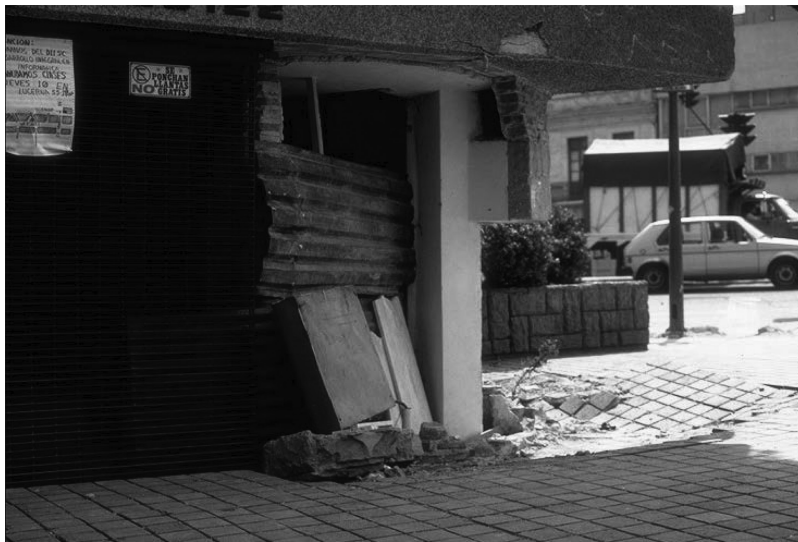
Figure 2.30 Bearing capacity failure in Mexico City (Michoacán Guerrero earthquake, 1985).

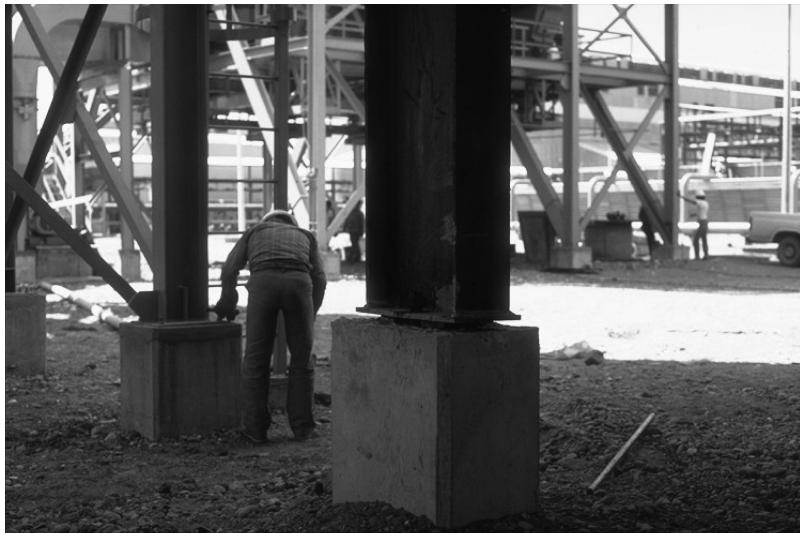
Figure 2.31 Earthquake-induced foundation settlement (Michoacán Guerrero earthquake, 1985).

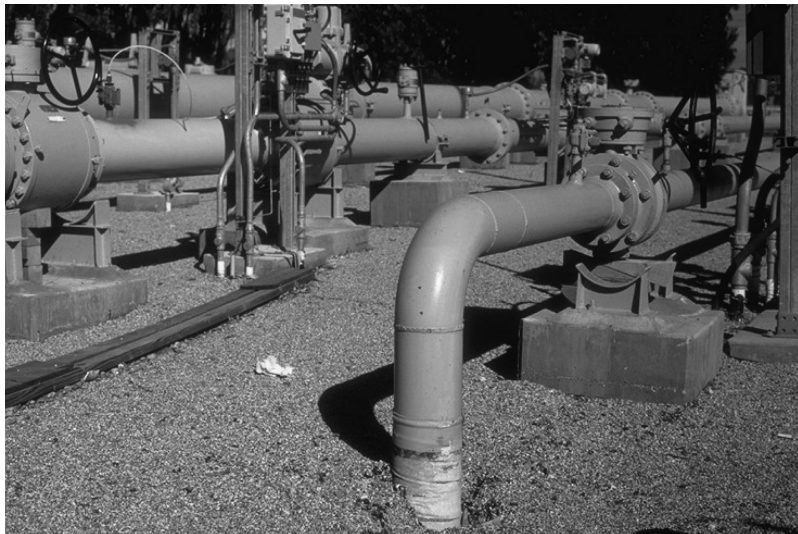
Figure 2.32 Settlement of a poorly compacted backfill (Moss Landing, Loma Prieta earthquake, 1989).

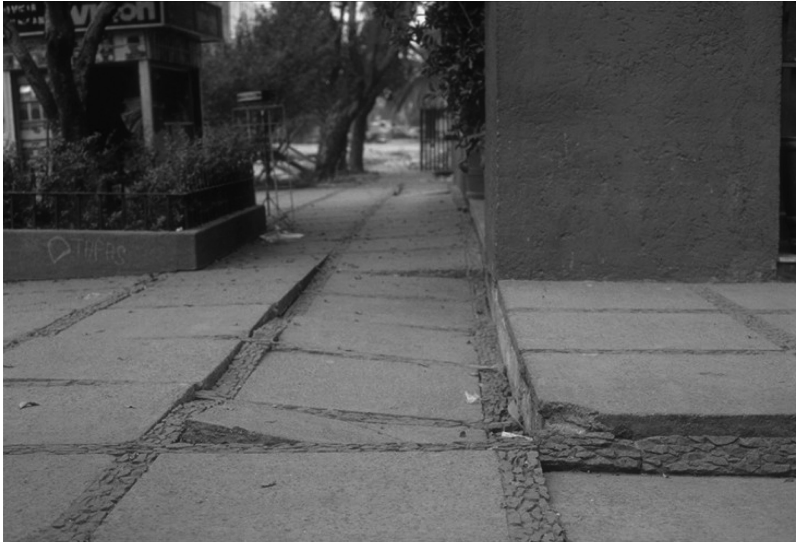
Figure 2.33 Settlement of a pipeline trench adjacent to a building (Mexico, 1985).

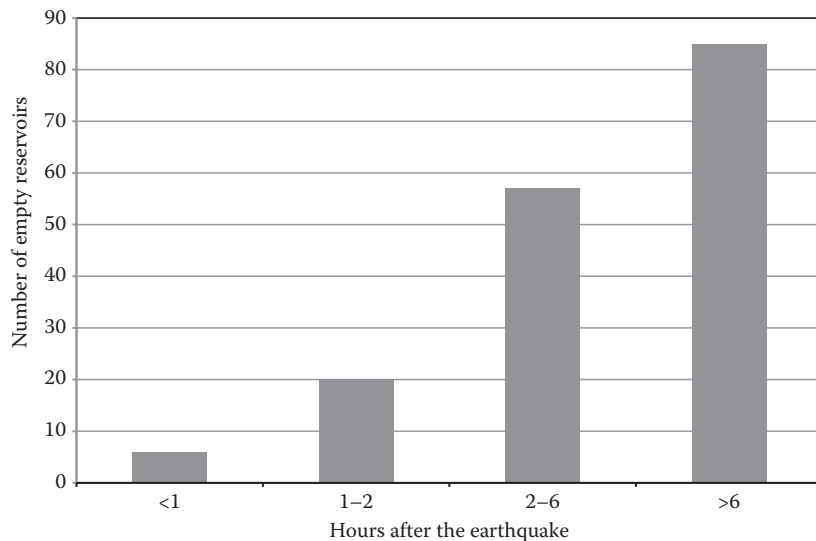
Figure 2.34 Loss of reservoirs after the 1995 Hyogo-ken Nambu earthquake. (Modified from O'Rourke, T.D. 1996. Lessons learned for lifeline engineering from major urban earthquakes. Paper no. 2172. *Eleventh World Conference on Earthquake Engineering*. Acapulco, Mexico.)

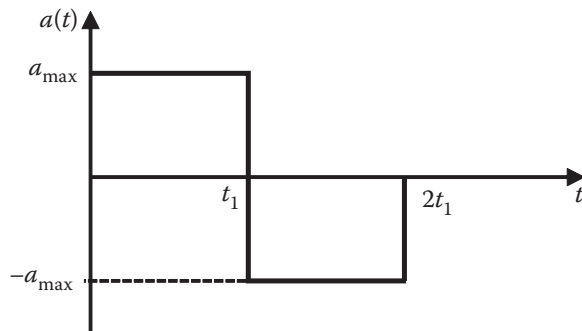
Figure 2.35 Ground acceleration for Question 2.1.

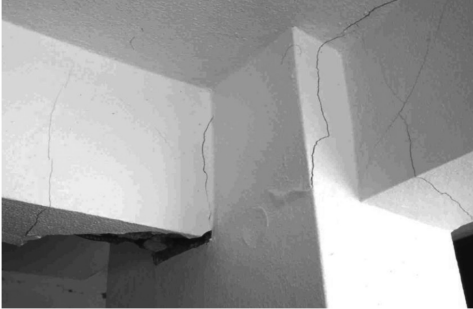
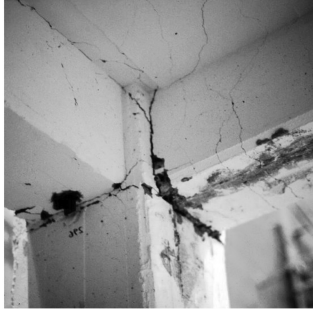
Figure 2.36 (a–c) Beams of Question 2.3.

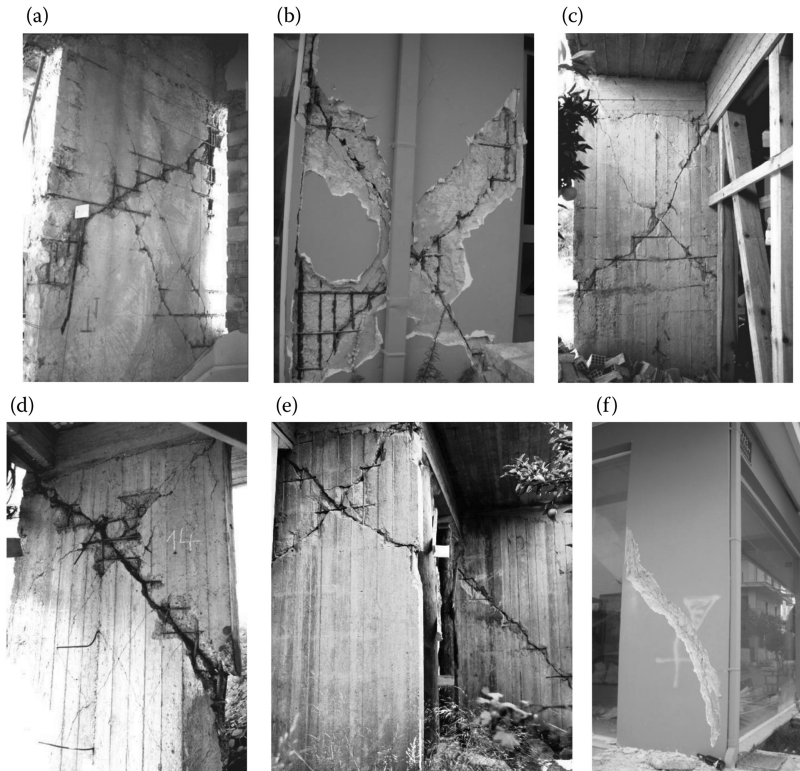
Figure 2.38 (a–f) Walls of Question 2.5.
